CEDAR CAMPUS / REPORT EXAMPLE / 25 OCT 2026

Asbestos building survey

Administration / Technical Services / Training Hall

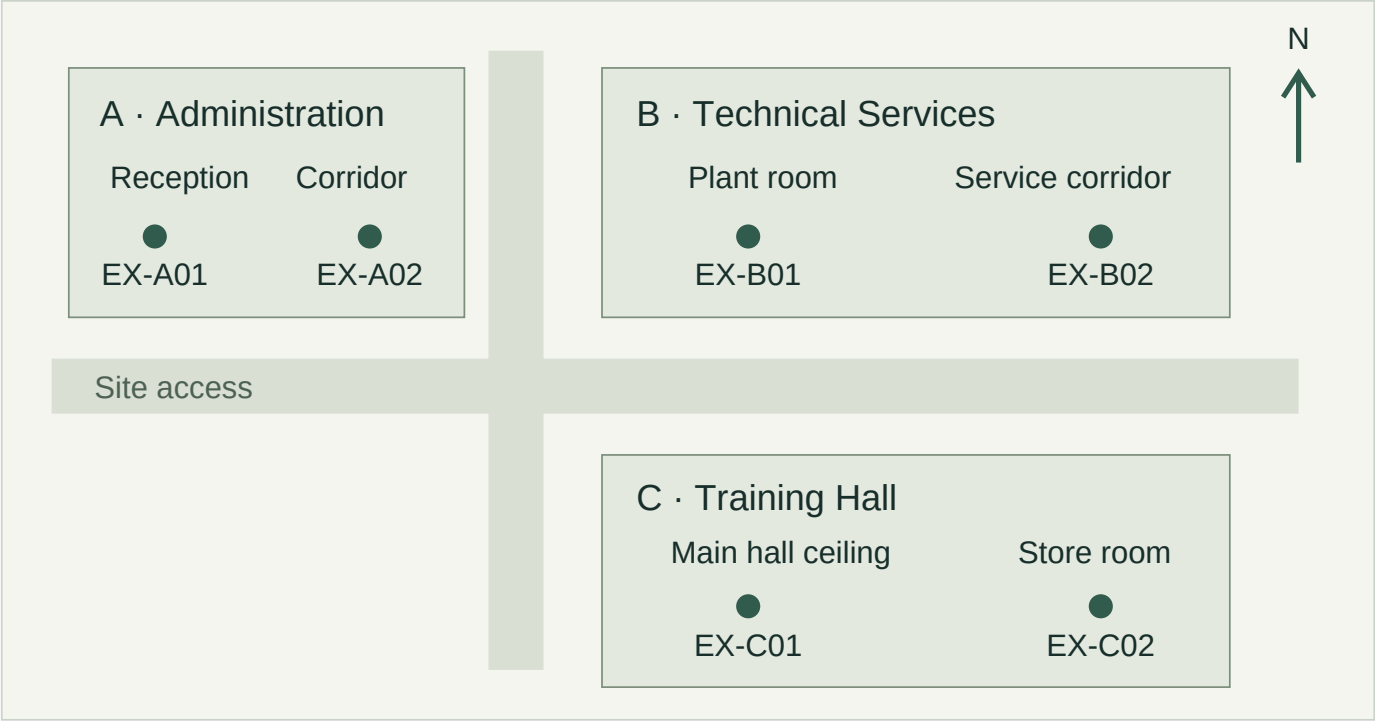
Site Plan

Schematic site layout - not to scale. Dots identify the six recorded locations.

Schematic, not to scale. Administration is west, Technical Services northeast and Training Hall southeast. Administration contains EX-A01 at the reception ceiling and EX-A02 in the east corridor. Technical Services contains EX-B01 in the plant room and EX-B02 in the service corridor. Training Hall contains EX-C01 at the main hall ceiling and EX-C02 in the store room.
